**EXPERIMENTAL INVESTIGATION OF THE
INTERACTION OF MOISTURE, LOW TEMPERATURE, AND
LOW LEVEL IMPACT ON GRAPHITE/EPOXY COMPOSITES-II**

PREPARED BY
K. N. LAURAITIS
P.E. SANDORFF

**LOCKHEED-CALIFORNIA COMPANY
BURBANK, CALIFORNIA**

FINAL REPORT
OCTOBER 1982

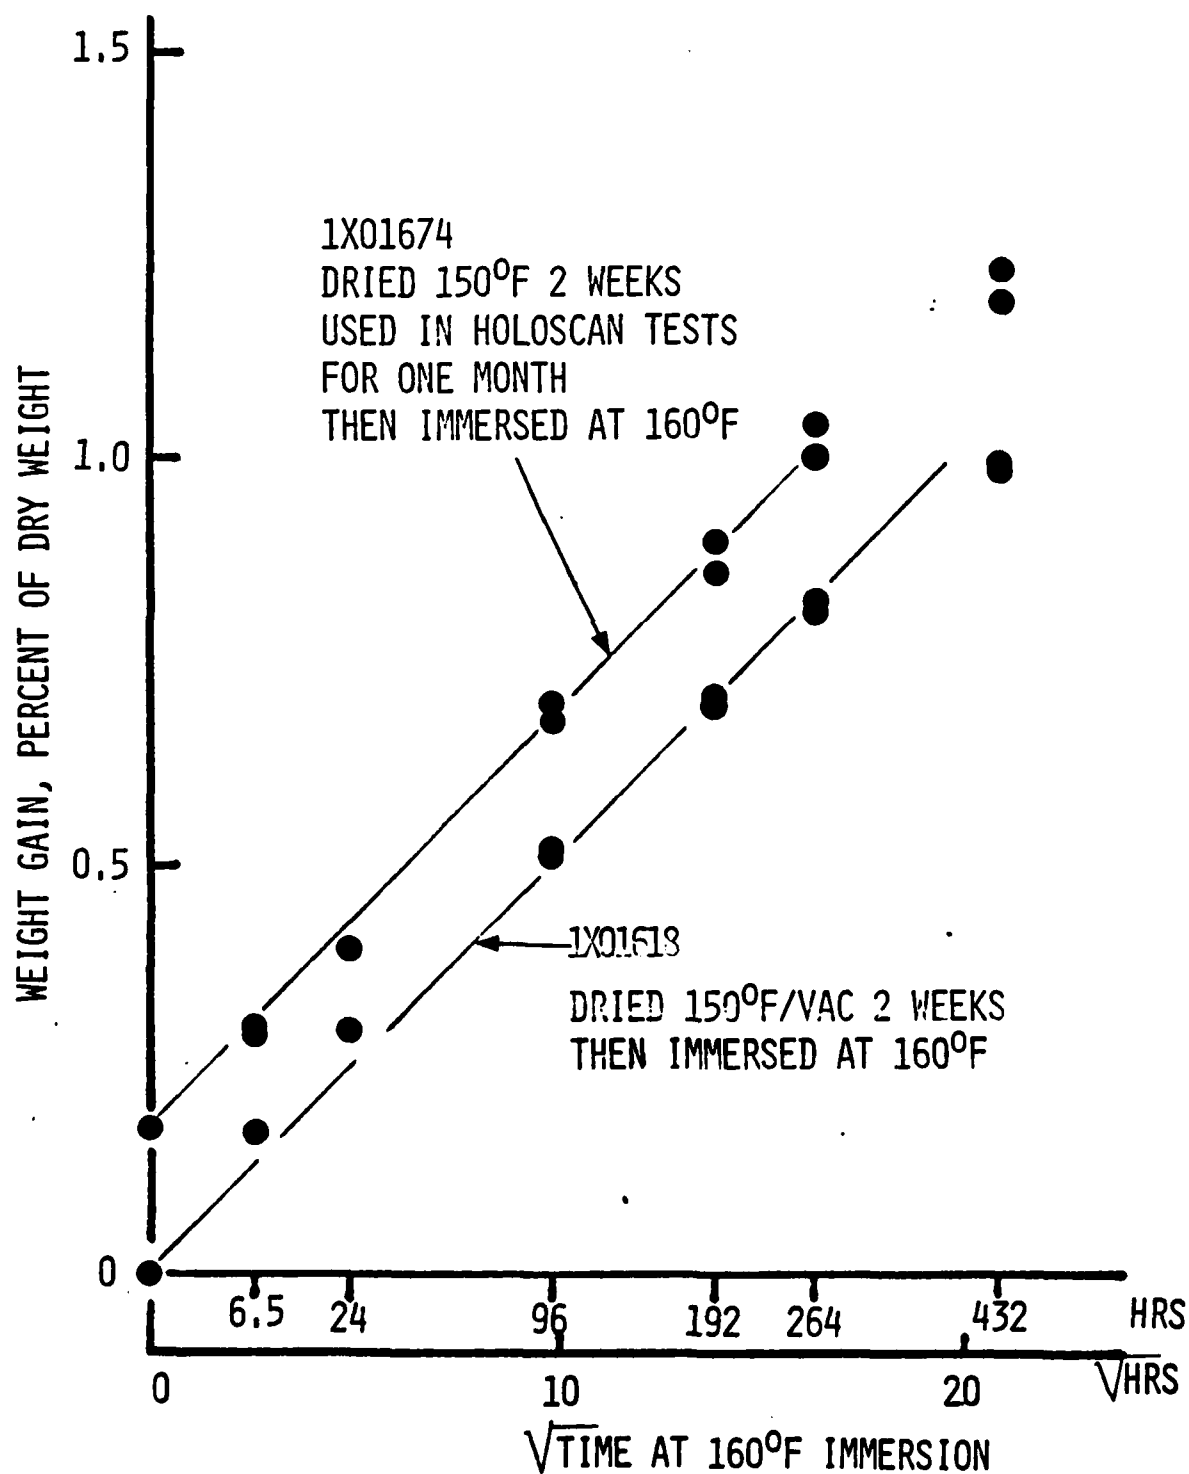
Figure 2.1: Moisture Absorption for Control (Undamaged) Coupons

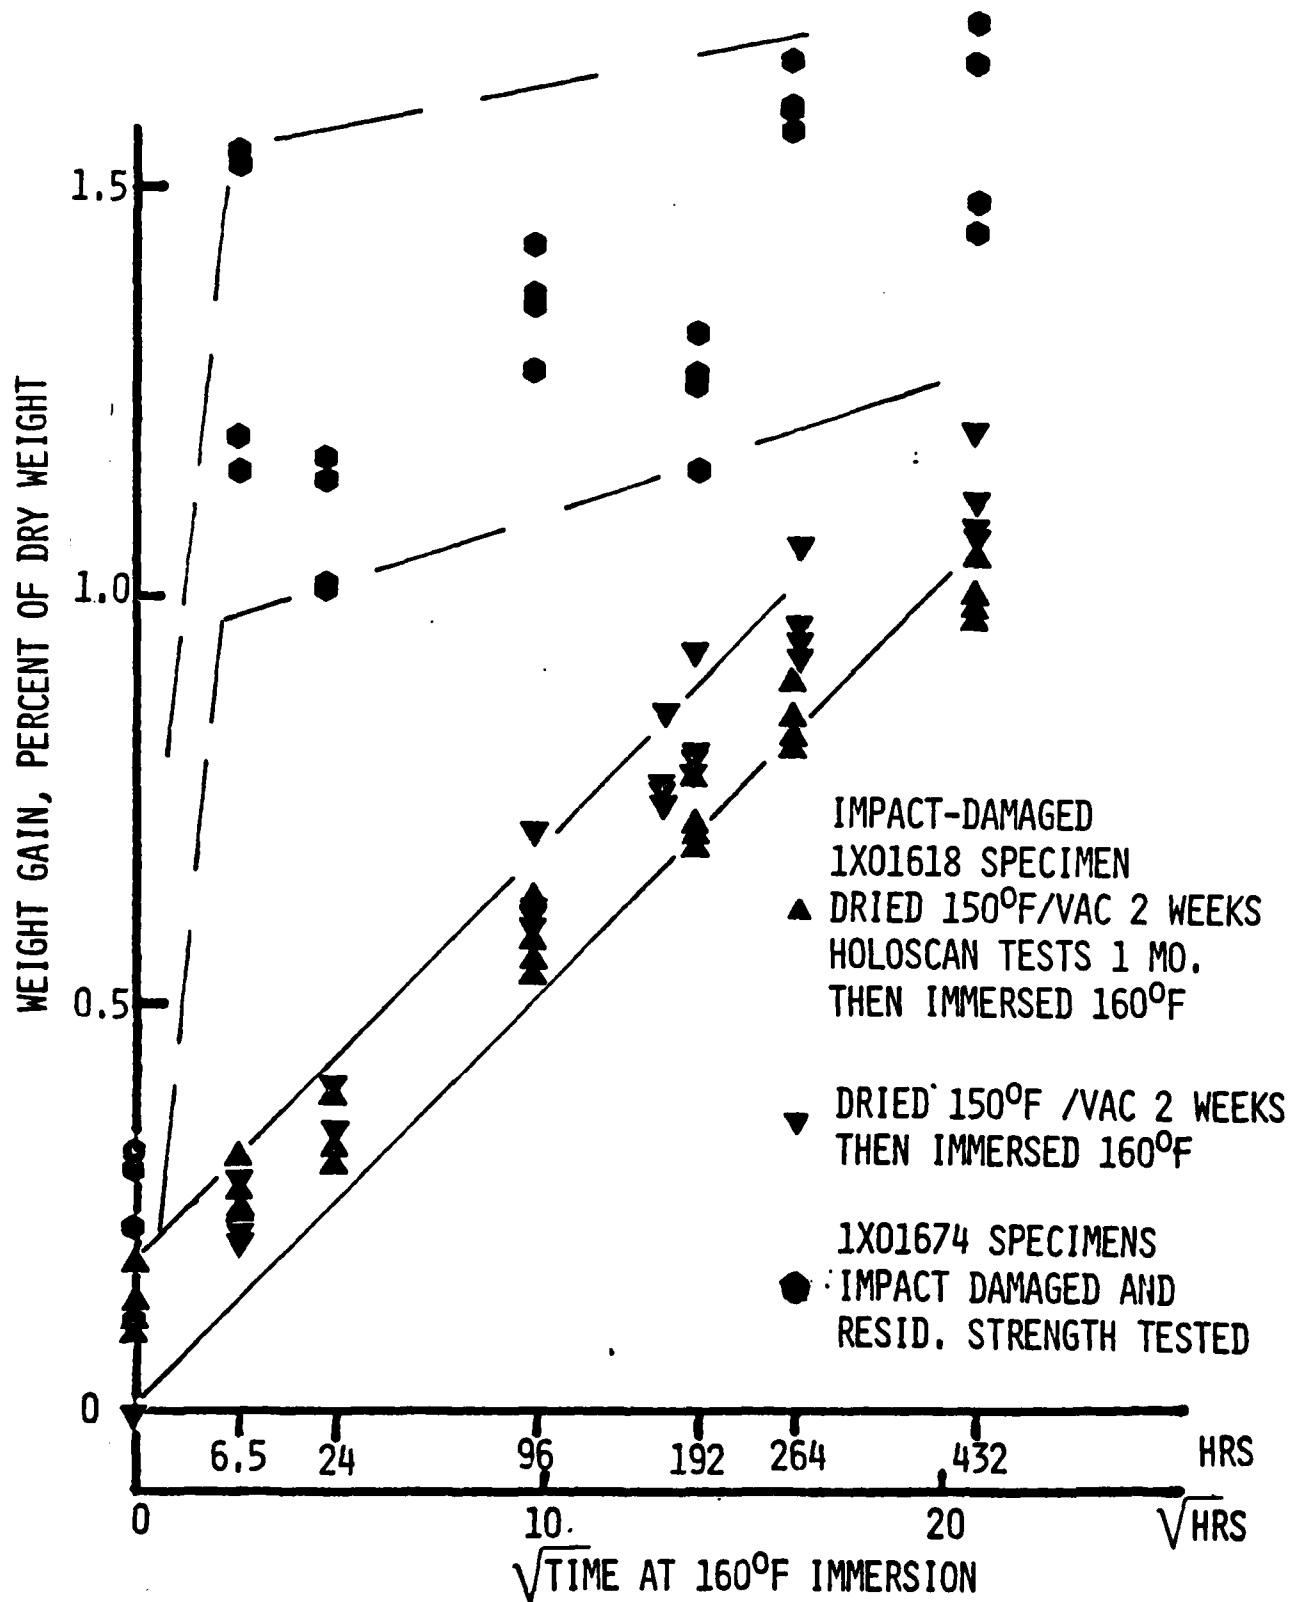
Figure 2.2: Moisture Absorption for Damaged Coupons

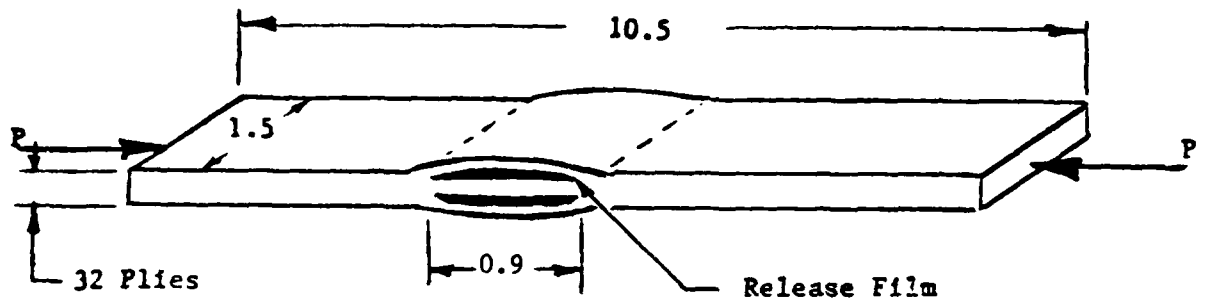
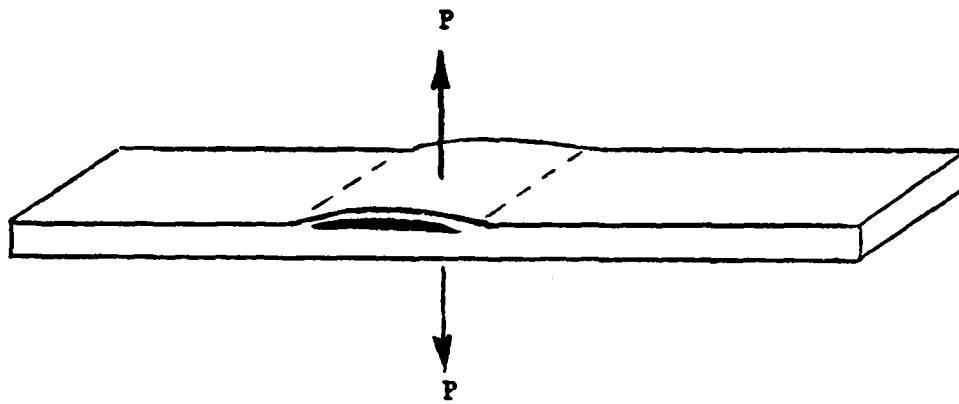
METHOD A

METHOD B

Figure 3.1: Specimen Loading Methods

A preliminary study was conducted to select the most viable loading techniques. The two methods illustrated in Figure 3.1 were evaluated. Test set-up and instrumentation for loading methods A & B are shown in Figures 3.2 and 3.3, respectively. Crack displacement was measured, front and back with linear variables differential transformers (LVDT's) in Method A while clip gages were used on both sides for Method B. Type A coupons contained two strips of release film located symmetrically from the outer surfaces to preclude eccentricity in the coupons. Both 1 mil and 1/2 mil thick films were evaluated in Type A coupons. Type B specimens contained only one strip of 1 mil thick release film. The compressively loaded Type A specimens were supported with 1/4-inch thick aluminum plates extending to within 1/2 inch of the initial delamination. Additional support could not be provided without clamping over the delaminated region. Slow crack growth could not be obtained with the Type A loading condition for either film thickness. Despite several modifications of the support fixture, no significant displacement was recorded or observed prior to the sudden and catastrophic failure. With the Type B loading condition slow crack growth could be obtained. However, considerable effort was expended in attempts to obtain uniform opening across the width of the coupon and to obtain more than one data point per coupon. Fairly uniform crack opening displacement (COD) was finally achieved through the use of hydraulic grips and testing under stroke control. This prevented sudden loss of the coupon due to rapid crack extension after the first "pop". Thus multiple COD readings at which crack growth occurred could be taken for various initial crack lengths and displacements. Therefore, the Type B specimen and loading method were selected for all subsequent tests. Crack lengths and displacements on both sides of the specimen were monitored as well as the load to produce extension for a given crack length. Crack lengths were measured with an

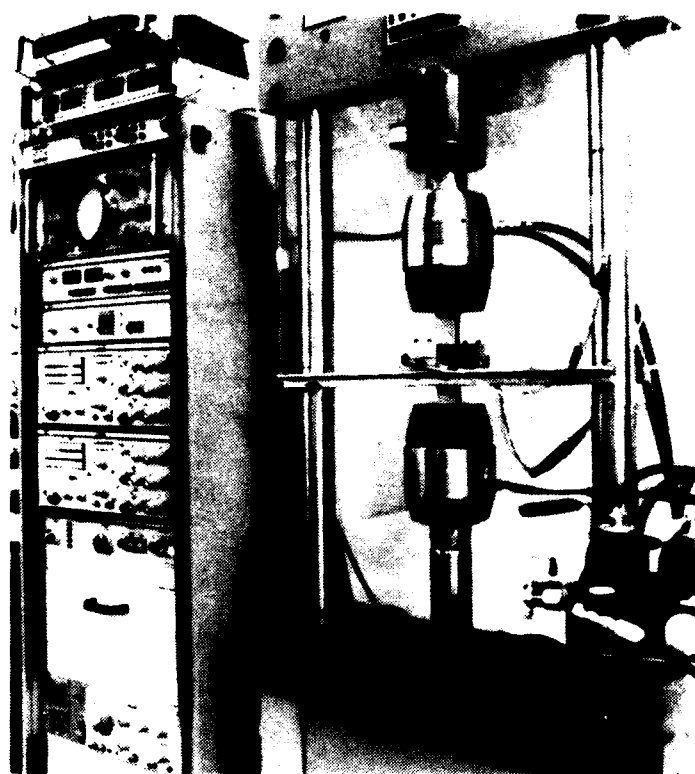
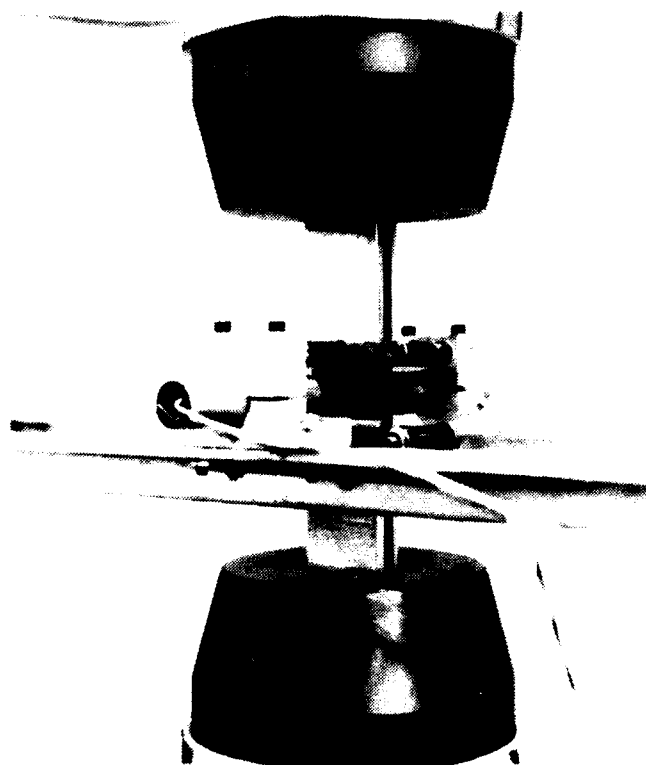
Figure 3.2: Test Set-up and Instrumentation For Method A

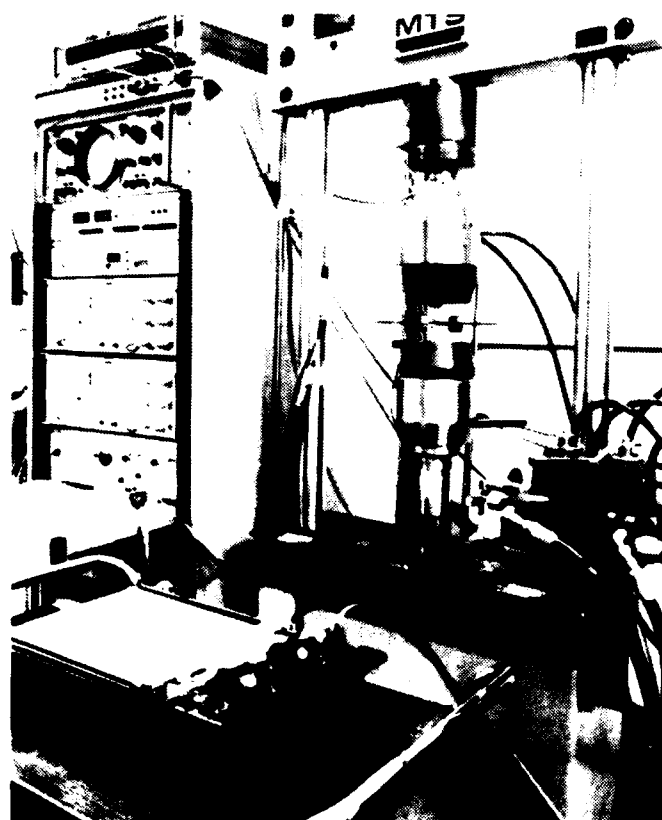
Figure 3.3: Test Set-Up and Instrumentation for Method B

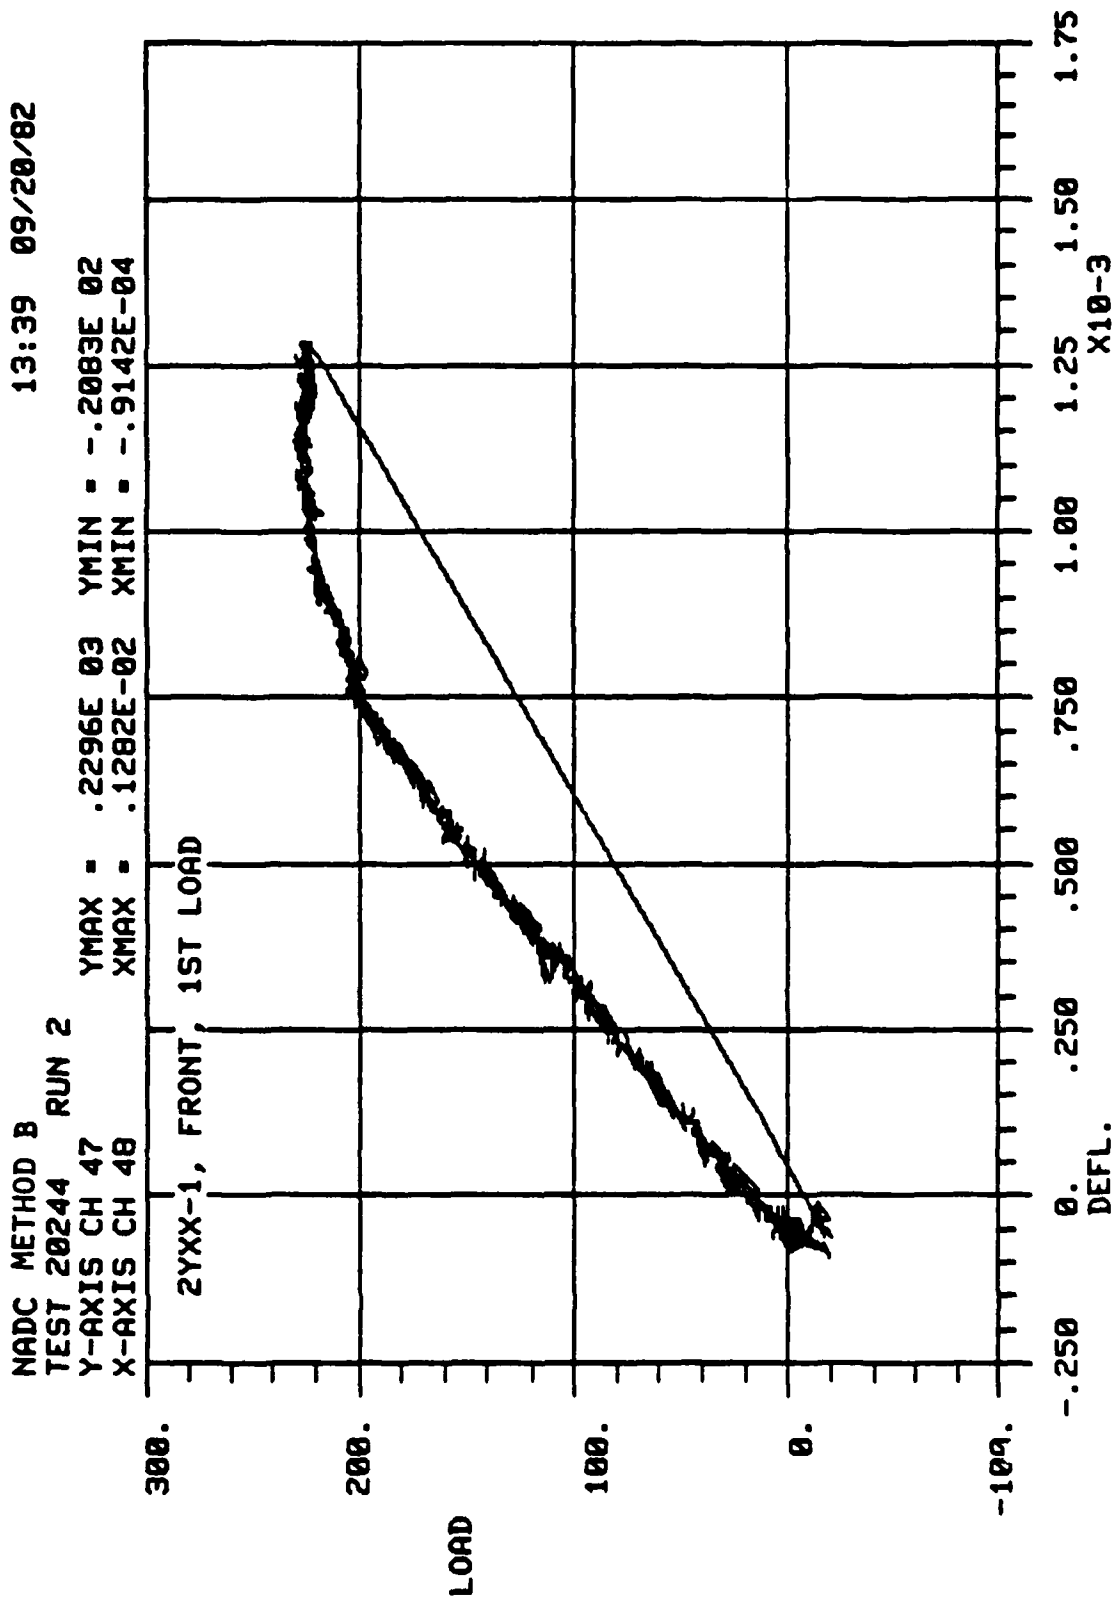
Figure 3.4a: Load vs. Crack Opening Displacement for Initial COD of 0.0001 in. and Initial Crack Length of 0.9 in. - Front Gage

NADC METHOD B
 TEST 20244 RUN 2
 Y-AXIS CH 47
 X-AXIS CH 49

optical microscope mounted on the test machine because of the difficulty in seeing the crack tip under no load, a small load (approximately 25% of maximum load) was maintained while the crack length was read. Selected results for specimens with a debond between the 7th and 8th plies (2YXX-1) and those with a debond between the 3rd and 4th plies (1YXX-4) are presented in Figures 3.4 through 3.8 and Figures 3.9 through 3.11, respectively. Table 3.1 contains a tabulation of the complete test results.

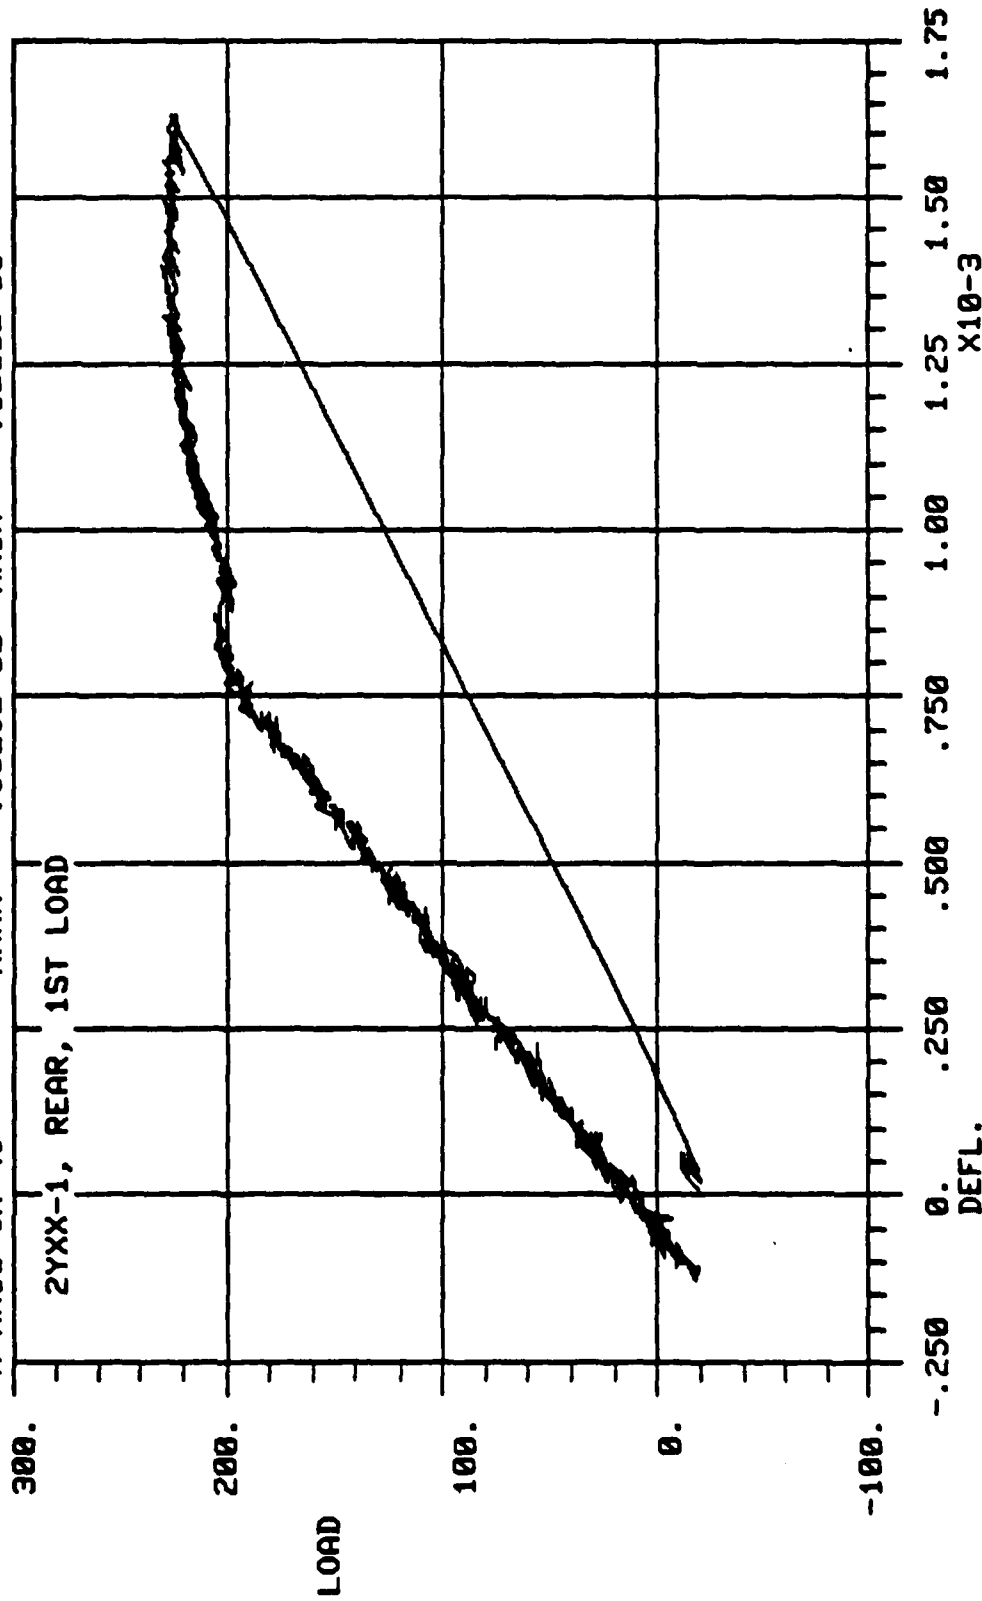
Figure 3.4b: Load vs. Crack Opening Displacement for Initial COD of 0.0001 in. and Initial Crack Length of 0.9 in. - Rear Gage

NADC METHOD B
 TEST 20244 RUN 6
 Y-AXIS CH 47
 X-AXIS CH 48

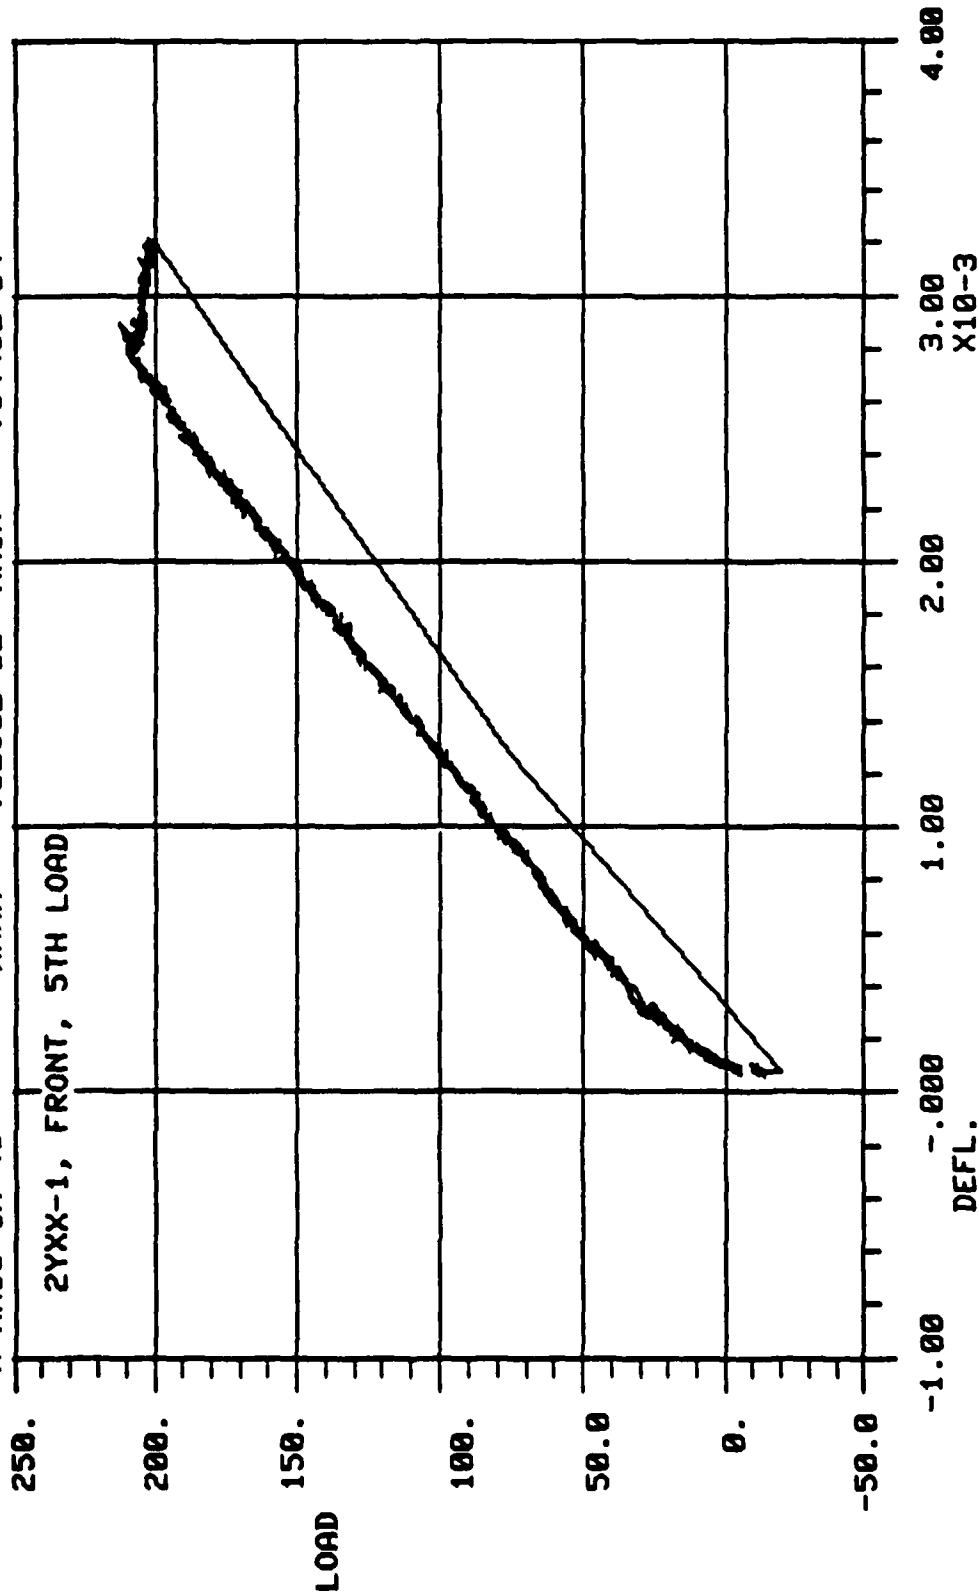
Figure 3.5a: Load vs. Crack Opening Displacement for Initial COD of 0.001 in. and Initial Crack Length of 1.016 in. - Front Gage

NADC METHOD B
TEST 20244 RUN 6
Y-AXIS CH 47
X-AXIS CH 49

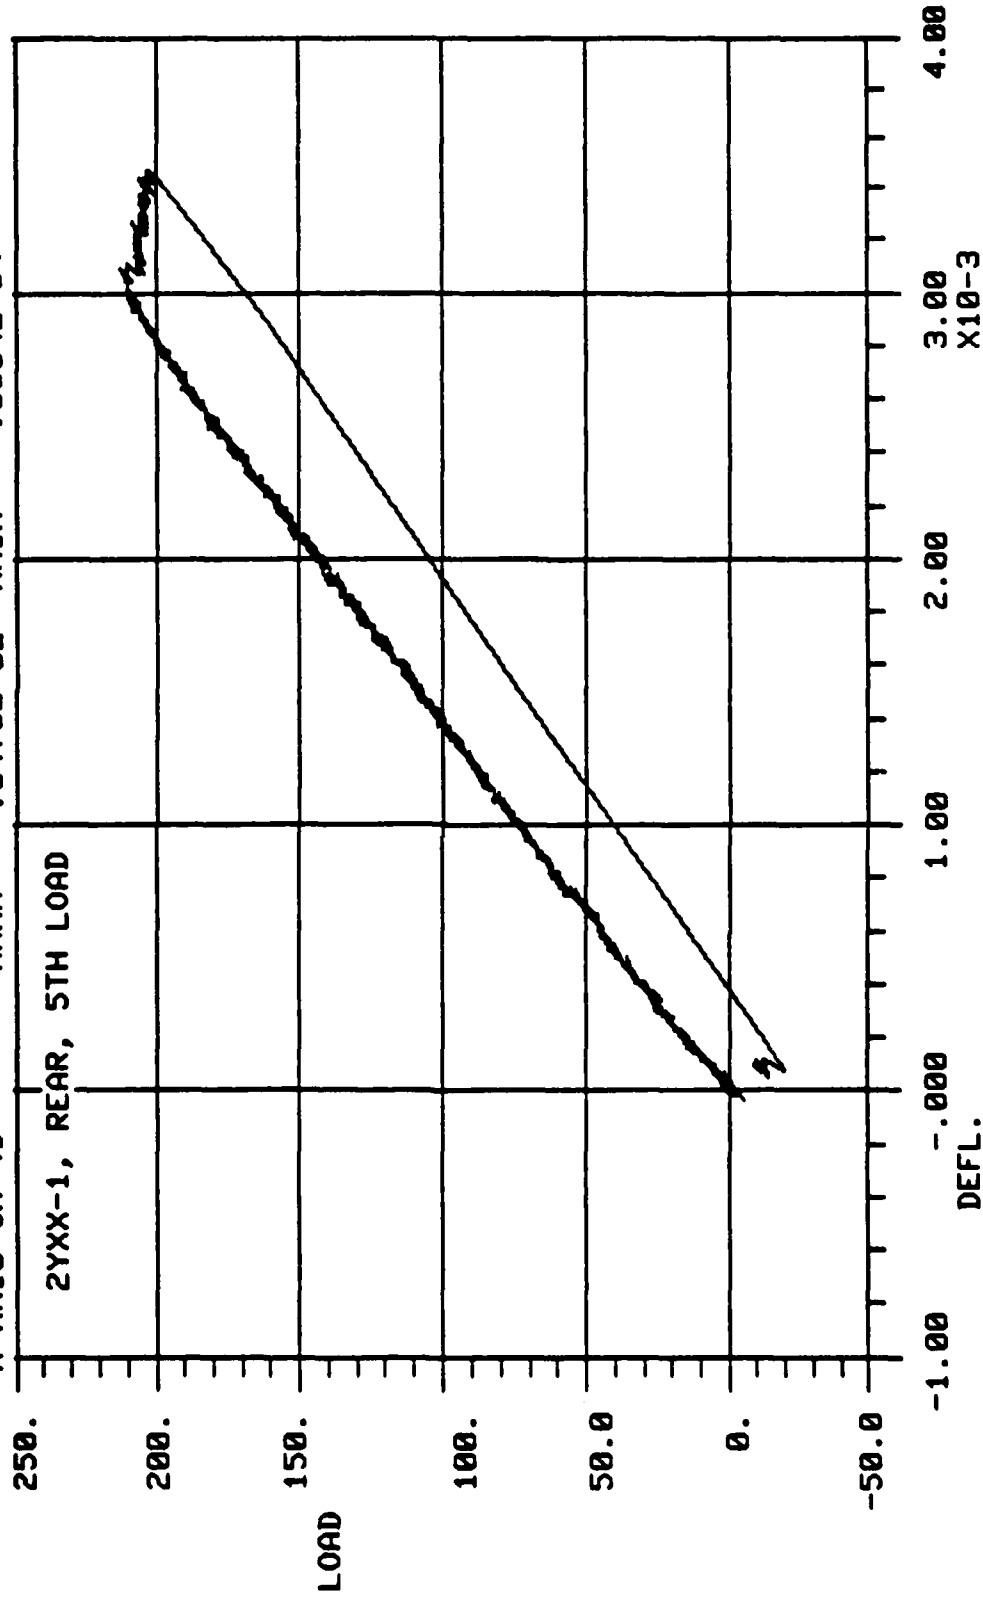
Figure 3.5b: Load vs. Crack Opening Displacement for Initial COD of 0.0001 in. and Initial Crack Length of 1.025 in. -- Rear Gage

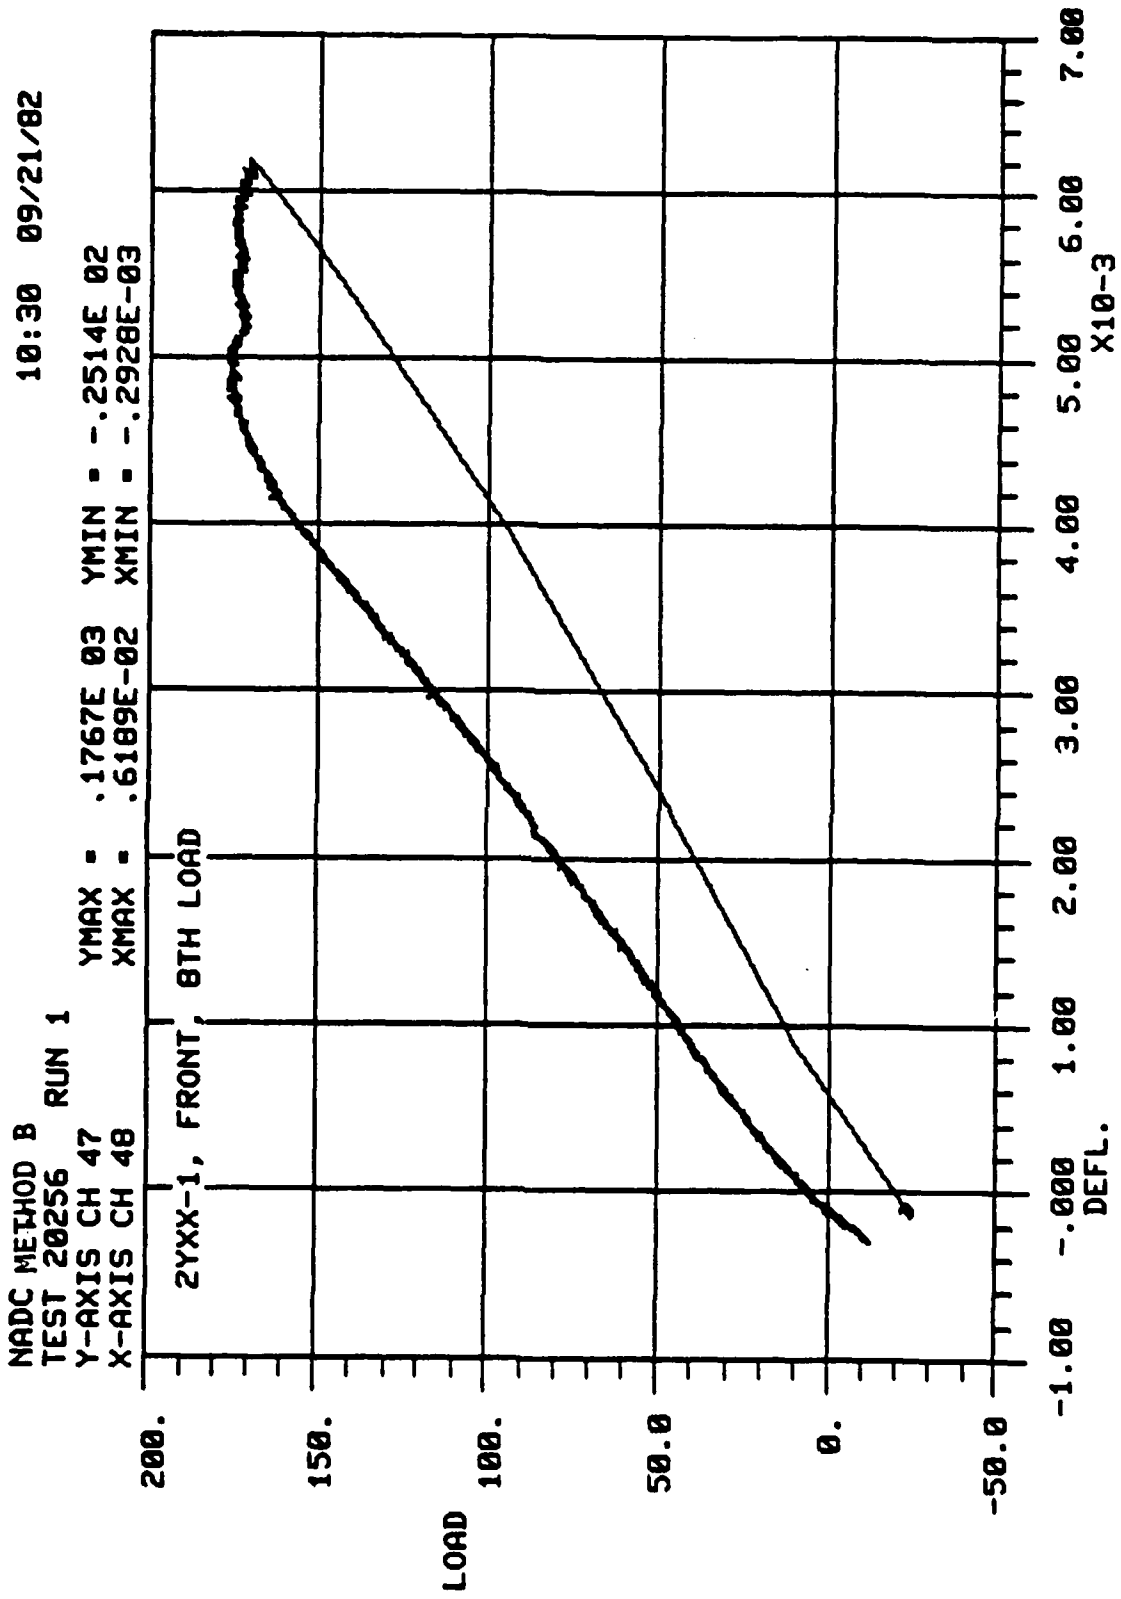
Figure 3.6a: Load vs. Crack Opening Displacement for Initial COD of 0.001 in. and Initial Crack Length of 1.231 in. - Front Gage

NADC METHOD B RUN 1
 TEST 20256
 Y-AXIS CH 47
 X-AXIS CH 49

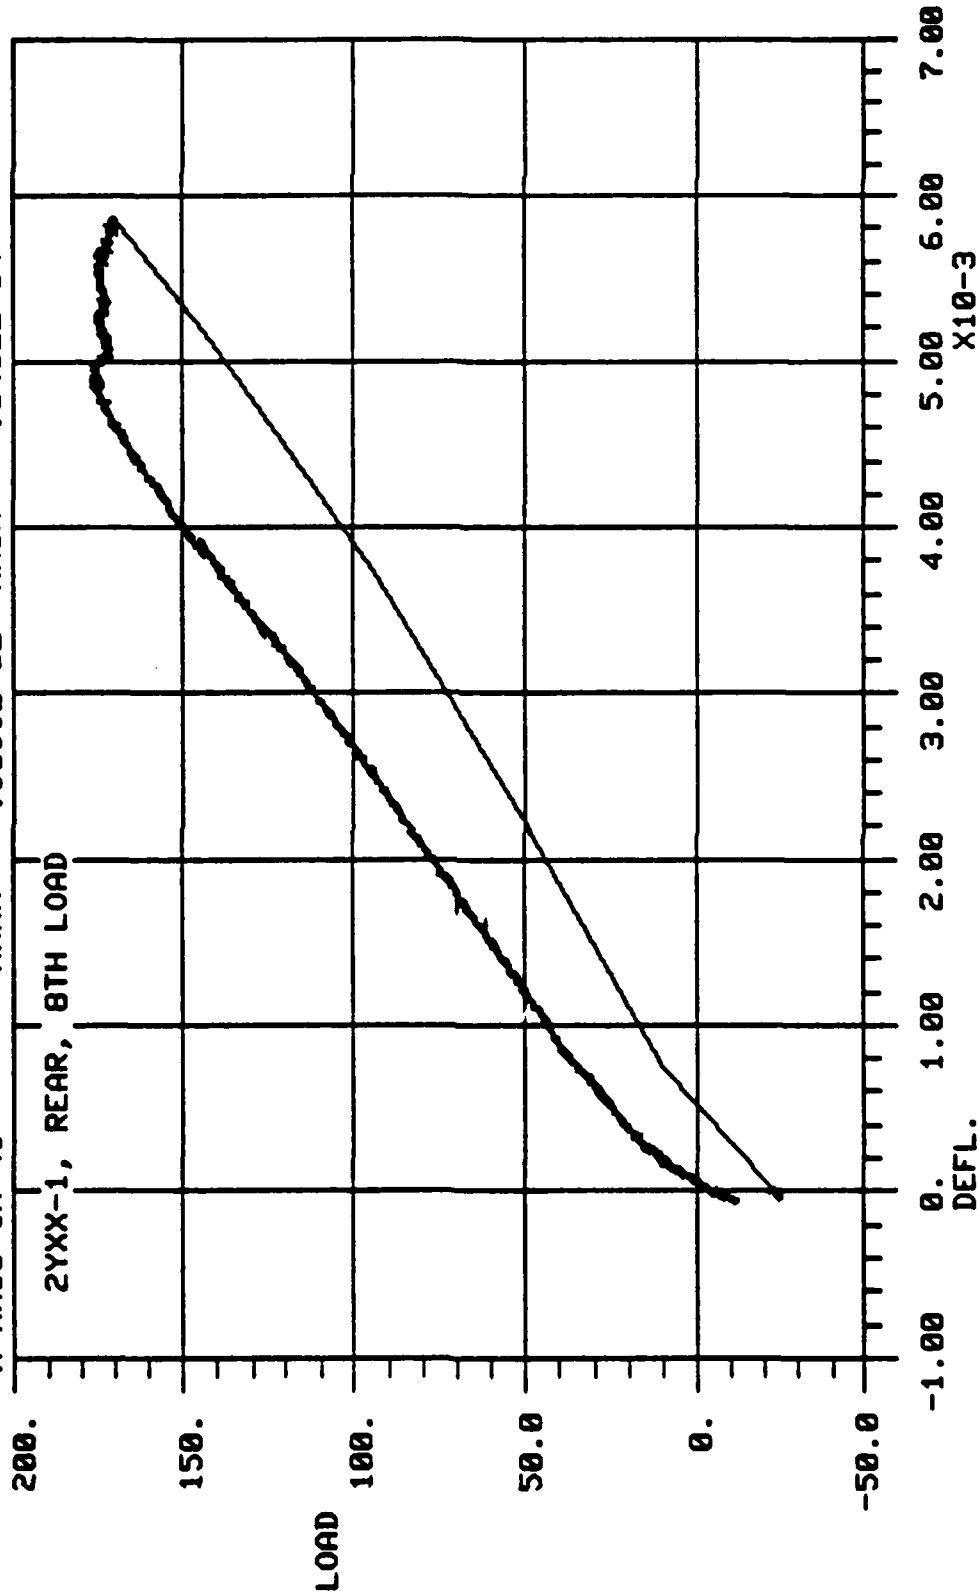
Figure 3.6b: Load vs. Crack Opening Displacement for Initial COD of 0.001 in. and Initial Crack Length of 1.200 in. - Rear Gage

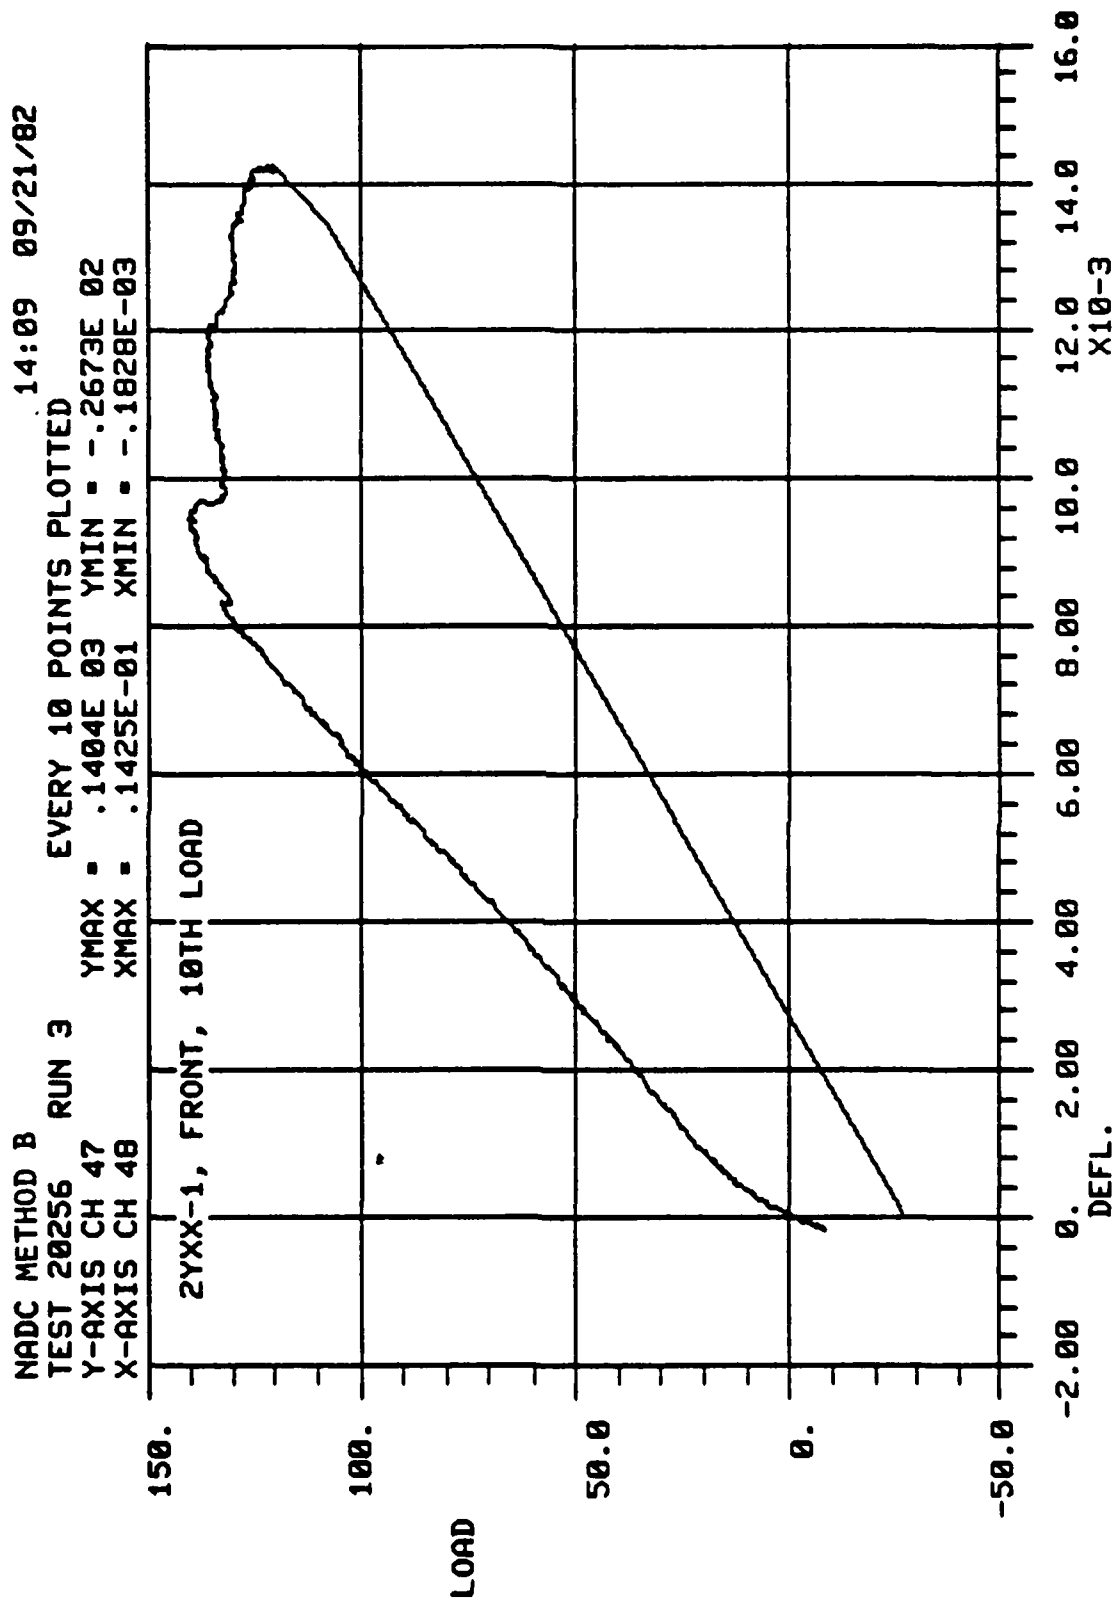
Figure 3.7a: Load vs. Crack Opening Displacement for Initial COD of 0.0013 in. and Initial Crack Length of 1.532 in. - Front Gage

NADC METHOD B
TEST 20256 RUN 3
Y-AXIS CH 47 YMAX = .1404E 03 YMIN = -.2673E 02
X-AXIS CH 49 XMAX = .1477E-01 XMIN = -.1556E-03

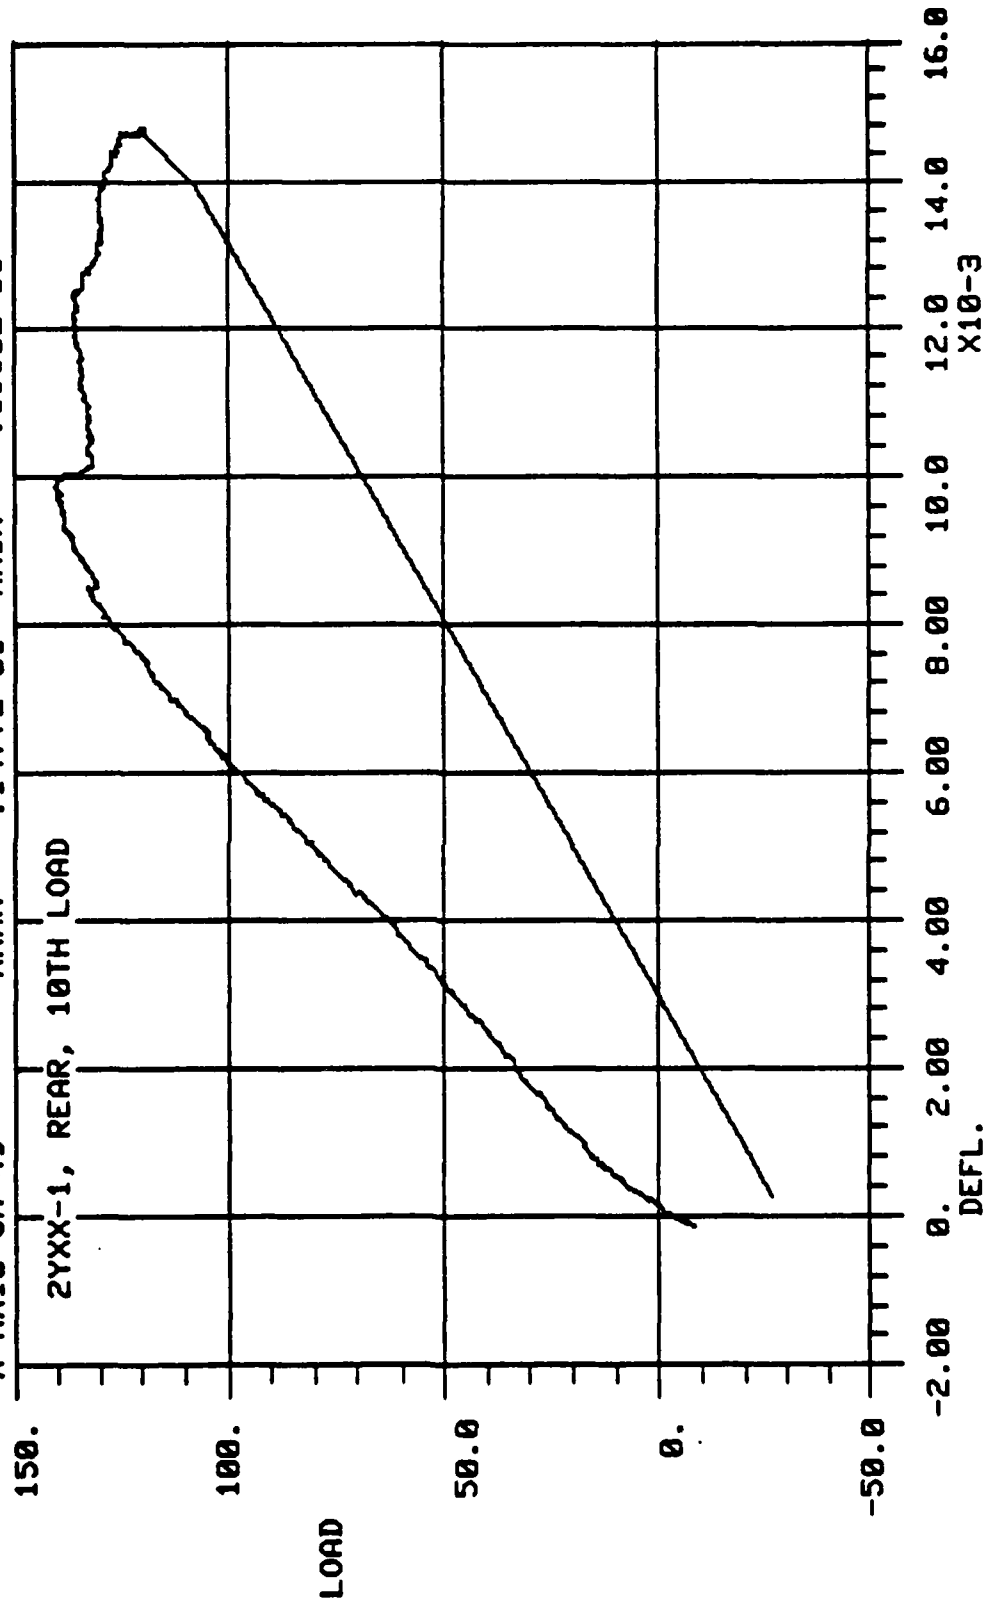
Figure 3.7b: Load vs. Crack Opening Displacement for Initial COD of 0.0019 in. and Initial Crack Length of 1.746 in. - Rear Gage

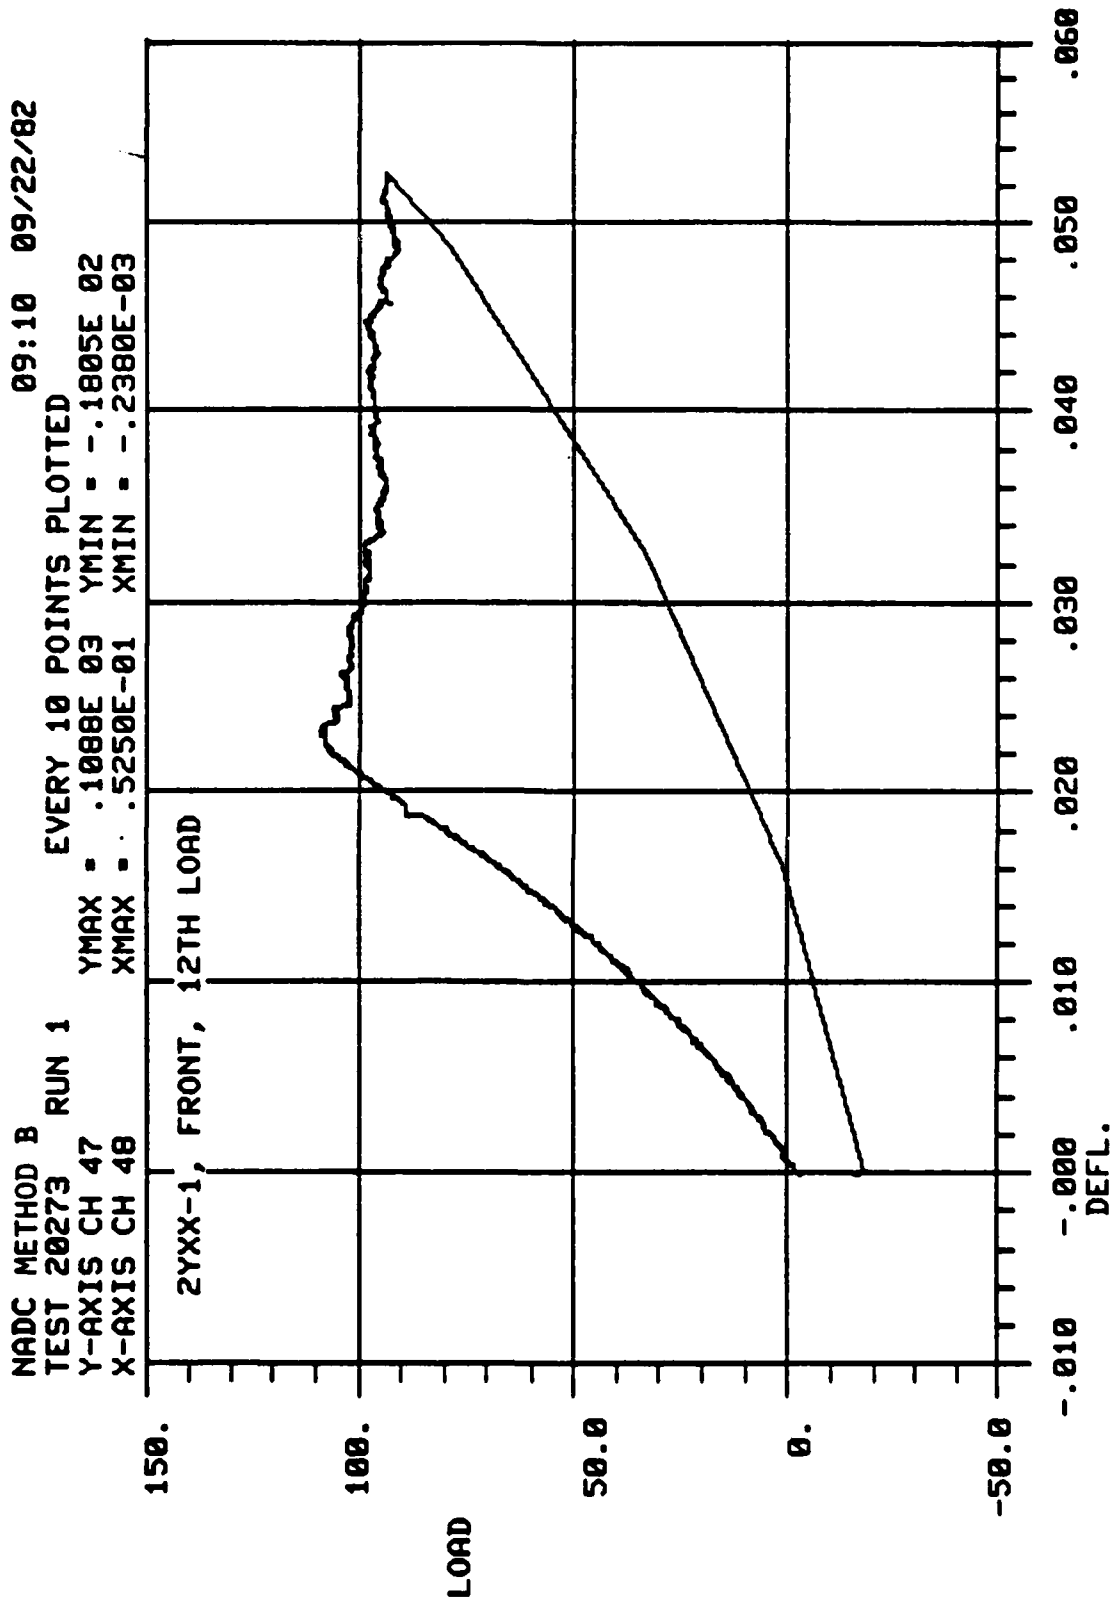
Figure 3.8a: Load vs. Crack Opening Displacement for Initial COD of 0.0026 in. and Initial Crack Length of 2.060 in. - Front Gage

NADC METHOD B RUN 1 09:10 09/22/82
 TEST 20273 EVERY 10 POINTS PLOTTED
 Y-AXIS CH 47 YMAX = .1088E 03 YMIN = -.1805E 02
 X-AXIS CH 49 XMAX = .5259E-01 XMIN = -.1649E-03
